Manhole Inspection Summary

Manhole # S13OO1001MH

Location Address: **2707 RUSCOMBE**

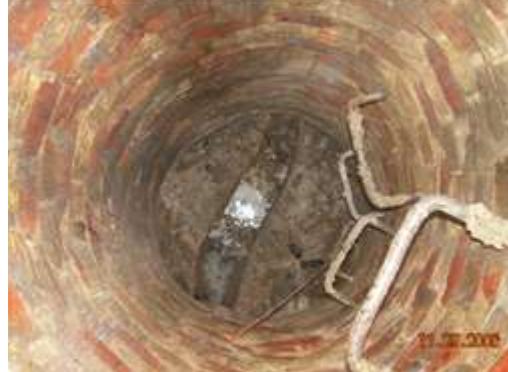
Top View

Barrel infiltration. Evidence of surcharge - Bench debris. Channel debris.

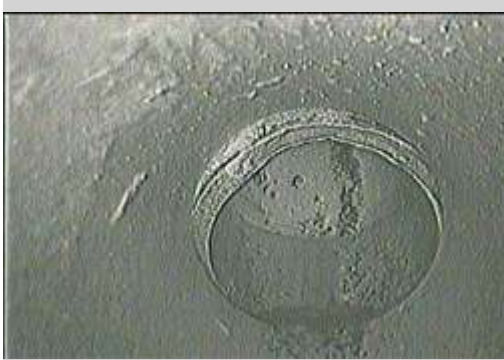
Inside the I7

Offset joint.

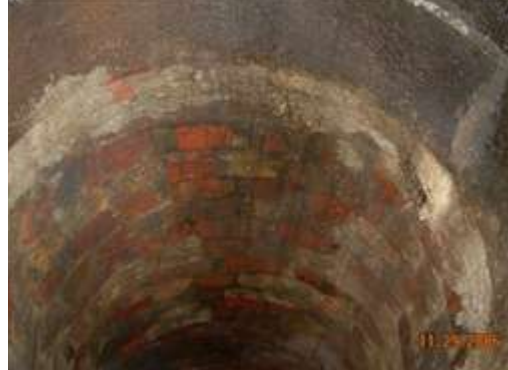
Defect

Frame leaks. Adjustment infiltration.

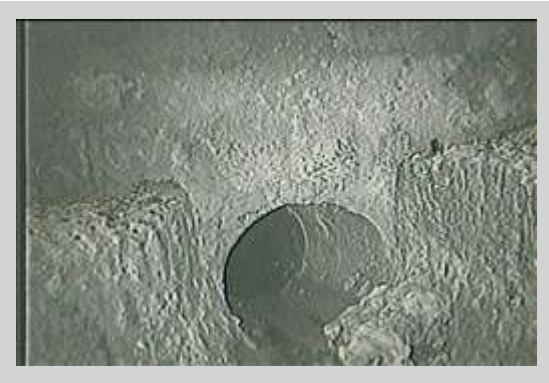
8 in. Circular Gravity Sewer Pipe Out @ 12 O'Clock

Deposits: ☐ None ☐ Mud ☐ Sludge ☒ **Debris** ☐ Grease

Silt Depth: **0** (in.) Deposits Extent: **Light**

Infiltration: **None** Pipe Seal Cond: **Cracked**
